SITE VISITATION REPORT – May.2015

SITE VISITATION AND CLARIFICATION OF WORKS ACCORDING TO DETAIL PROJECT

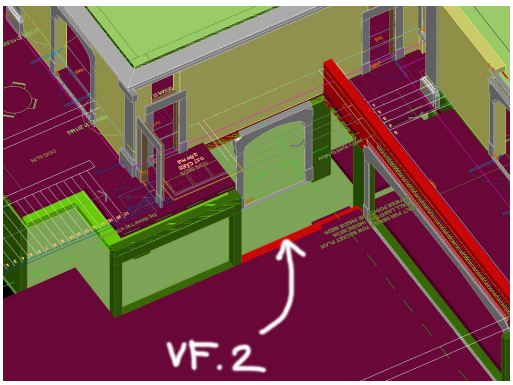
1 Verification and clarification of concrete beams in garage area at floor level for casting of basement concrete slab

- Solved, corrected by structural engineer and revised drawings updated on site

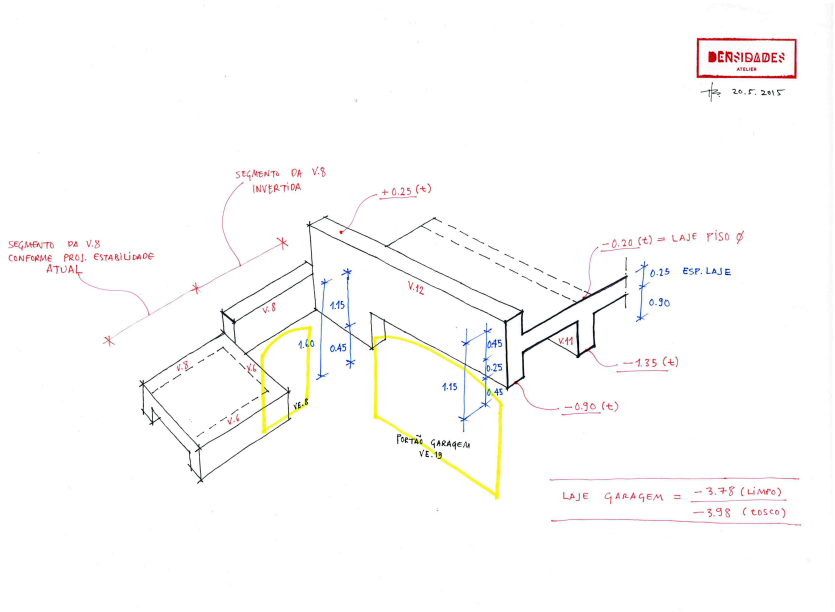
3 Verification and clarification of concrete beams in garage area at ceiling level for casting of ground floor concrete slab
- Solved, corrected by structural engineer and revised drawings updated on site

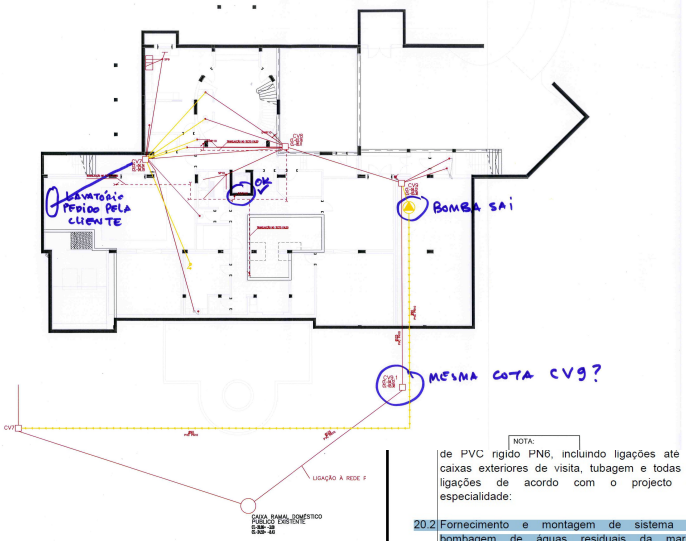
4 Sewage piping verified since one sewage box had no sloping angle from previous. Change in layout proposed by Lux and agreed by email exchange between myself, Lux and Andrew.
- Solved, no costs involved, should actually be a discount made to James regarding point 20.2 of Lux's quote since, to my knowledge the sewage pumps will not be installed.
